LOCAPAL

# Fault analysis completed in double quick time

A comprehensive fault analysis carried out quickly and efficiently on a bridge enabled French temporary structures specialist Locapal to make the rights decisions without delay.

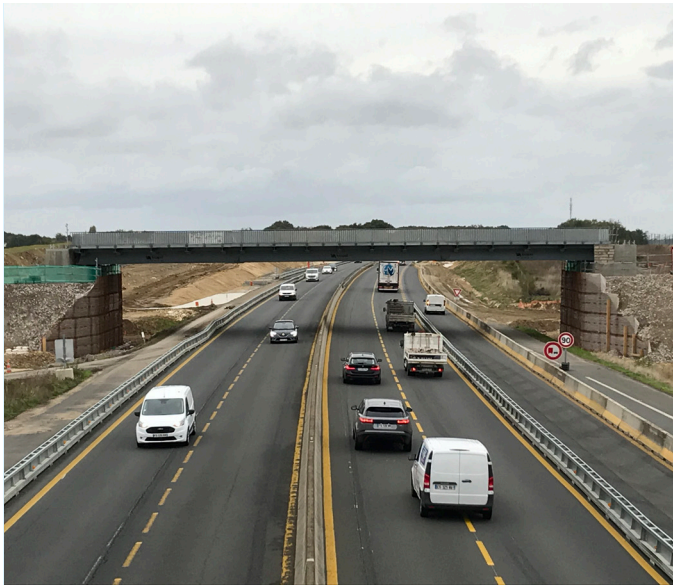
A temporary bridge over a motorway was ready for commissioning when a fractured bolt came to light. As safety is always Locapal's first priority, the site management team immediately returned the bolt to the manufacturer and asked for an explanation. The manufacturer's verdict was that the problem most probably stemmed from incorrect tightening. For Locapal, whose teams of fitters work to strict assembly instructions, this explanation sounded highly implausible. The suspect bolt was then sent to Cetim for a second, independent assessment.

From the very first analyses carried out using the facilities available at the Centre laboratories, it was evident that the fracture surface was not the result of faulty tightening. As Locapal had suspected, the bolt manufacturer's explanation simply didn't hold water. Commissioning of the bridge was suspended with immediate effect while Cetim performed more extensive metallurgical analyses. These analyses revealed a problem of intergranular decohesion; a fault that could clearly not be put down to over-tightening, but was in all likelihood caused by a manufacturing issue, specifically during the heat treatment phase. This meant that all the bolts used in the assembly of the bridge presented a risk of

fracture. On Cetim's advice, Locapal took the decision to replace all the M30 bolts, numbering some 500, in the structure. However, to ensure the safety of the bridge, the company first commissioned the Centre to check the compliance of a number of bolts from the new batch. Both metallurgical characterisation and mechanical testing confirmed their compliance with the relevant requirements. The process of replacing each bolt in the structure one by one took a total of 16 hours.
