Alstom Power

# Recommendations for painting cabinets

Was the corrosion affecting Alstom Power's cabinets caused by a paint problem or an exogenous reason? The industrial company found the answer, strengthened its investigative powers and provided recommendations.

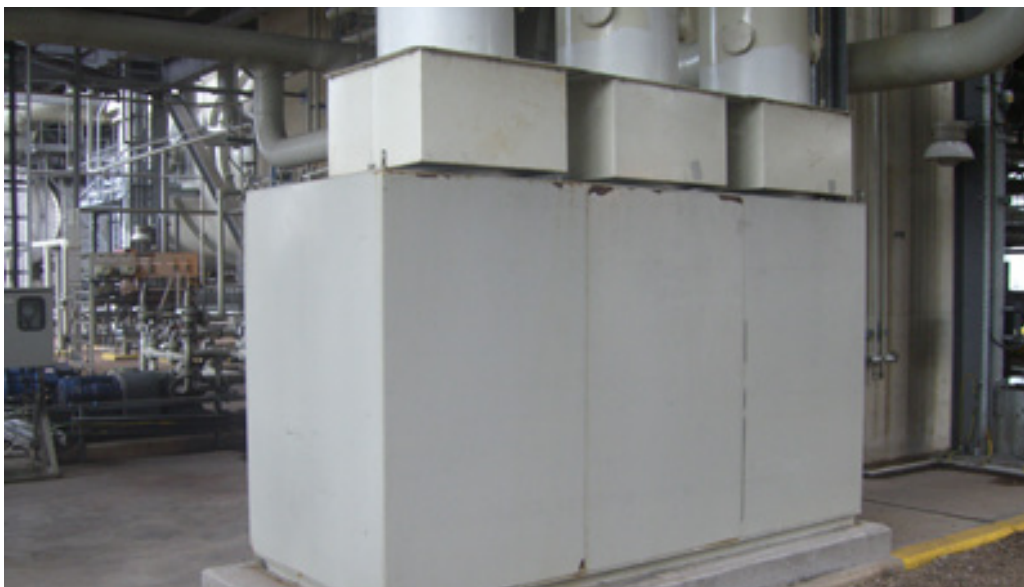
the ambient air generated by the industrial site itself.

the layers and inspected the surfaces to try and detect the preparations. In the laboratory, infrared examination using the samples taken on site helped to determine the chemical nature of the paints. Next, differential scanning calorimetry revealed a two-fold cause for the failure under investigation: incomplete curing and paint that was inadequate for the environment in question.

The contextual study was based on standard ISO 12944, which applies to the match between a paint system and an environment. The result was that the cabinet was not only subjected to salt air but also to the aggressive nature of

Cetim ultimately advocated a repair procedure, which Alstom Power imposed on its sub-contractor in charge of painting the cabinet sheets: careful sanding (the new requirements are based on standard references), a layer of epoxy primer and a layer of intermediate epoxy followed by a polyurethane layer with comprehensive controlled curing (passing through an oven).

This solution has subsequently shown its effectiveness.
