# Detailed analysis of cracking in cast iron components

While carrying out maintenance on the engines that power the Leclerc tanks, Wärtsilä detected cracks on the cast iron volutes of the turbine engines and asked Cetim to determine the root cause of this damage.

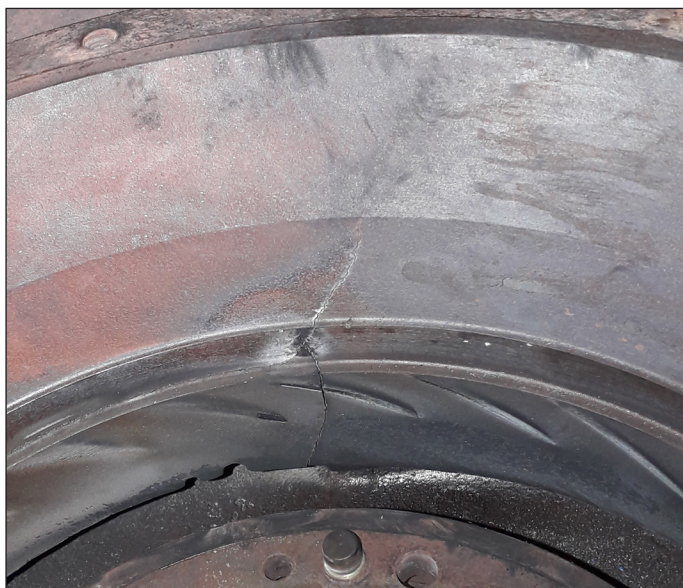
Three of the damaged volutes sent to Cetim were selected to undergo a series of examinations: metallographic, fractographic, chemical analysis, mechanical strength tests, etc. The fractography revealed that in each case the crack occurred in an area of low material thickness (1.2 to 2 mm instead of the regulatory 3 mm). Here in these thinner areas, the material was less resistant to temperature stresses. *“The presence of a thicker wall on the directly opposite side corroborated the assumption that the sand core used to make the tubing during casting had become offset,”* disclosed Gilles Regheere, a foundry, forging and hot metallurgy specialist at Cetim.

properties well below normal, so further tests were carried out. These uncovered and excessively low density of graphite particles, counterbalanced by an excessively high volume fraction of chromium carbides. This inappropriate composition of the cast iron results in lower thermal conductivity, which in turn causes premature damage due to thermal fatigue. To make matters worse, the nodularity of the graphite particles was noticeably poor. The uneven nature of the graphite particles created initiation points that generated stresses which were a further cause of cracking. *“In the end, this spheroidal graphite cast iron, that had been made defective by a cold lap, shortened the service life of the part to 1,410 hours,”* pointed out Gilles Regheere.
