Towards the use of passive and active infrared thermography to inspect metallic components in the mechanical industry

by S. MAILLARD*, J. CADITH*, D.ESCHIMESE*, H. WALASZEK*, J.L. BODNAR** and J.C. CANDORE**

* CETIM – EPI, Ingénierie de l'Instrumentation, 52, avenue Félix Louat, 60300 Senlis (France), samuel.maillard@cetim.fr

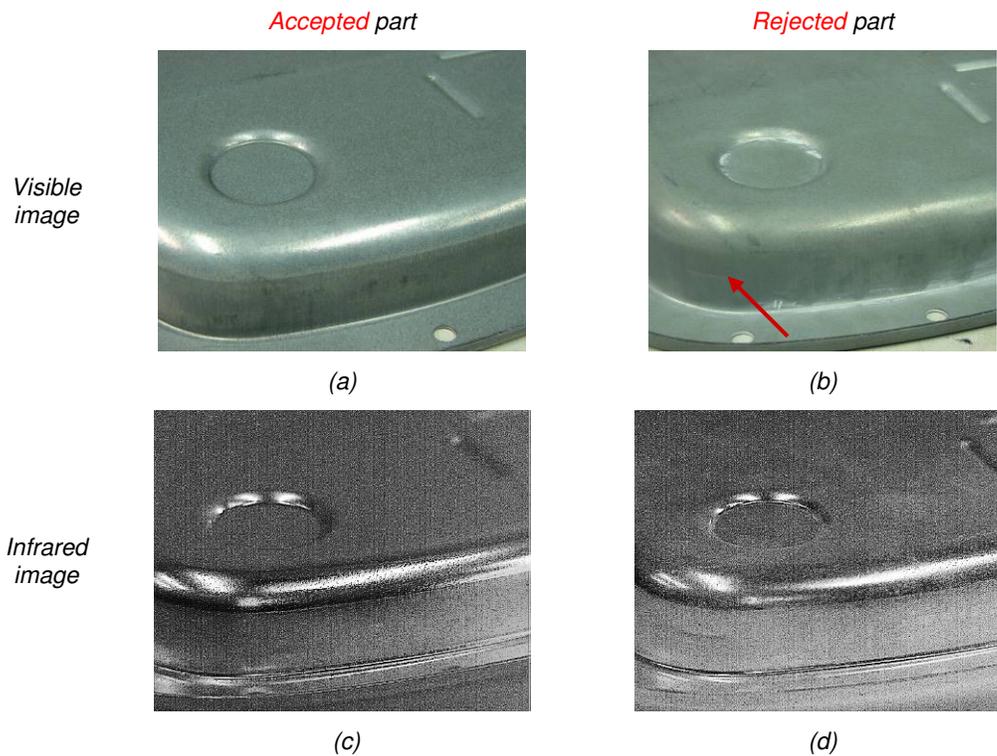
Thermal images were also achieved on **accepted** and on **rejected** parts. They were compared with images of the same parts obtained in the visible range. Examples are given in the figure 1.

Fig. 1. Comparison between images obtained in the visible and in the infrared range on stamped parts subjected to closed crack apparition

Image obtained in the visible range slightly highlight the presence of the closed crack but during on-line inspection, the detection is disturbed by the presence of a hot lubricant film on the sample surface. In field measurements have shown that thermal images overcome this drawback. On-line inspection should thus be achieved on such images using conventional algorithms for crack detection.

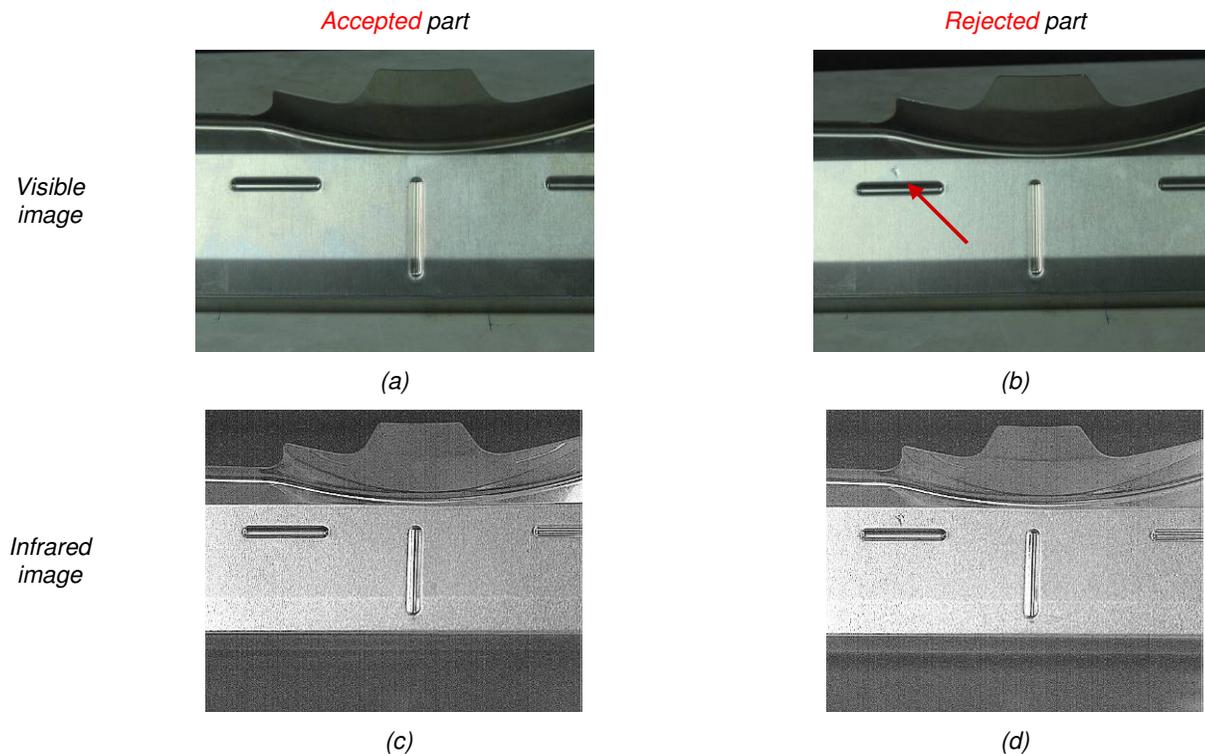
In figure 2, thermal images are compared with images obtained in the visible range on parts with and without surface defect. These parts are made of stainless steel and covered by the lubricant film layed on the metal sheet during the forming process.

Fig. 2. Comparison between visible and thermal images on stamped parts subjected to surface defect

Whereas conventional vision inspection is strongly dependant on the lighting for bright material, thermal images afford to detect surface even on material usually not considered for infrared thermography because of their low emissivity (aluminium, polished stainless steel, ...).

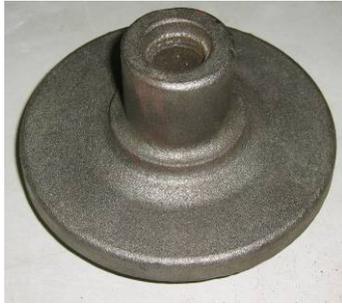
(a) Forged hub with a crack running from the flat surface to the radius

Fig. 3. Photos of the two forged components controlled

In this paper, conventional methods were applied on a hub (figure 3.(a)) and on a ballrod (figure 3.(b)). Images are then compared with thermal images obtained through several kind of excitation (laser, flash, induction).

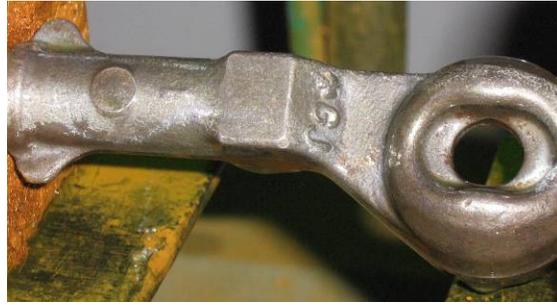
(b) Ball rod

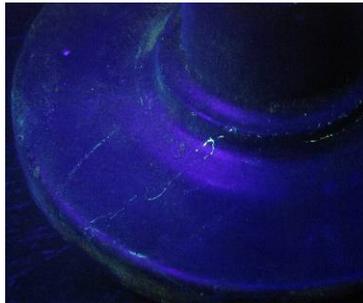
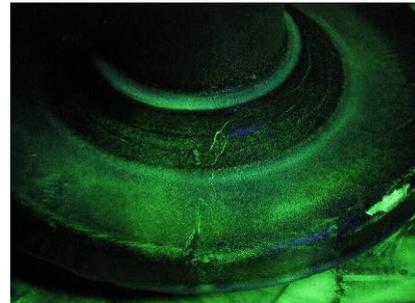
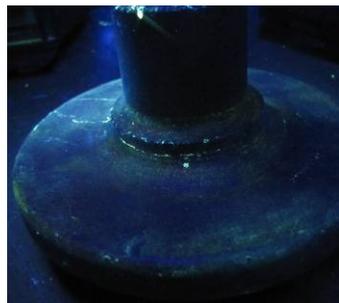
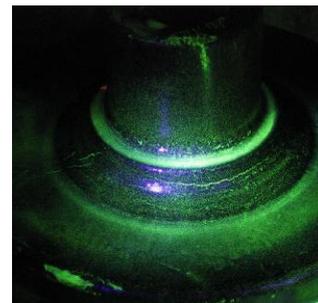
On the figure 4, as well penetrant testing as magnetic particle inspection images highlight indications that correspond to a crack that goes from the flat surface of the hub and propagates in the curved section.

Crack on the flat surface

Crack in the curvature

Fig. 4. Images obtained by penetrant testing and magnetic particle inspection on a cracked forged hub

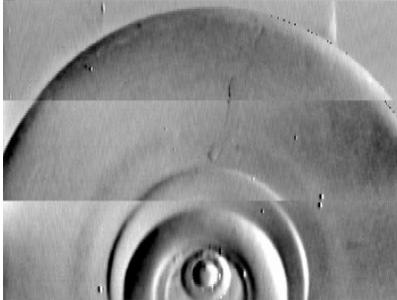
In the 80's, active thermography applications using a laser as excitation source were developed [2,3]. It allows to detect as well open crack as closed crack up to 5,0mm deep. Such a control was achieved on the forged hub. The reconstructed image is presented on the figure 5. The observation angle does not allow to observe the crack in the curved section but the shape on the flat surface of the indication looks like the one obtained by conventional NDE methods. The inspection rate of such a device is estimated to be about 1,5m²/h.

Fig. 5. Thermal image obtained by active thermography using a laser excitation on the flat surface a cracked forged hub

Through these measurements, it seems that laser and Eddy current excitation allow to detect open and closed crack (up to 5,0mm) whereas flash excitation only allow to detect open crack. Flash, which has short life duration regarding the number of samples to control, will have to be used in dedicated box to prevent damage for operators. Laser excitation should be the right solution when production rate is not a criteria. Eddy current excitation is finally of particular interest to inspect productions of parts with repetitive shape where a specific Eddy current probe could be designed.

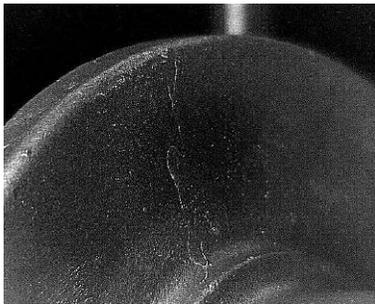
The same sample was also submitted to a flash excitation (3,5kJ). Images obtained at the moment flash are presented in the figure 6 for two different angles.

(a) Crack on the flat surface

Fig. 6. Thermal image obtained by induction thermography on a cracked forged hub

Indications observed in these images are clearly identical to the ones obtained by conventional NDE method and crack is then properly detected.

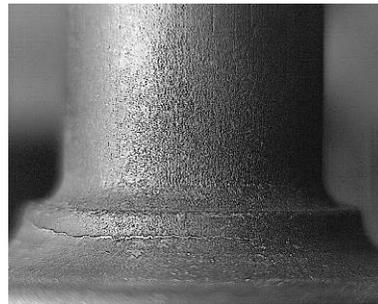
(b) Crack in the curvature

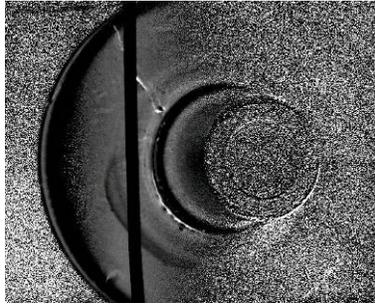
Eddy current excitation was also used as external heat source on this part. The hub was submitted to a Eddy current pulse of about 50ms duration at about 150kHz and the temperature decrease was analyzed. Figure 7 corresponds to the phase image obtained. The black line observed on this image is due to the presence of the inductor.

Both indication located on the flat surface and in the curved section clearly appear in this image.

Fig. 7. Phase image obtained by induction thermography on a cracked forged hub

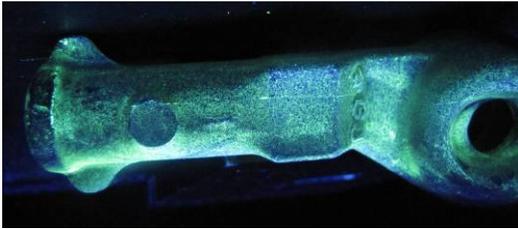
Magnetic particle inspection highlight a continuous line along the surface of the ballrod. This indication appears, but not so clearly, on the penetrant testing image. It is may be because crack is somewhere closed.

(a) Penetrant testing image

Fig. 8. Images obtained by penetrant testing and magnetic particle inspection on a cracked forged ballrod

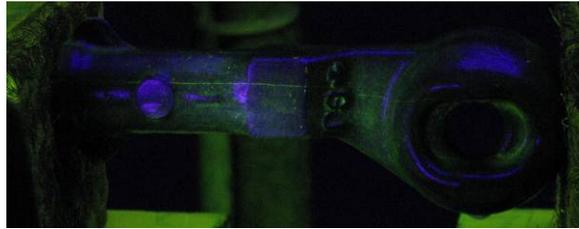
(b) Magnetic Particle Inspection image

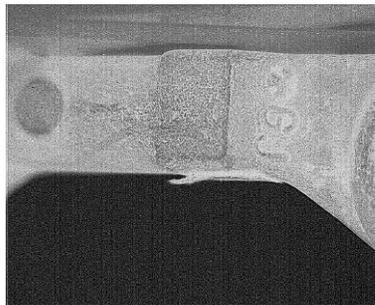
Thermal image obtained at the moment of the flash excitation is presented on the figure 9. There is no particular indication observed, even when the camera and/or the flash are closer to the analyzed surface or with any observation angle. It then seems that, for such thin defects, limits of the technique are reached.

Fig. 9. Thermal image obtained by flash thermography on a cracked forged ballrod
